ALTERNATIVE FUELS COMPATIBILITY WITH ARMY EQUIPMENT TESTING – AGED NIEDNER RIFTS CONDUIT TESTING

**INTERIM REPORT
TFLRF No. 426**

**by
Oliver P. Harrison
Southwest Research Institute®
Structural Engineering Department**

Contract No. W56HZV-09-C-0100 (WD15)

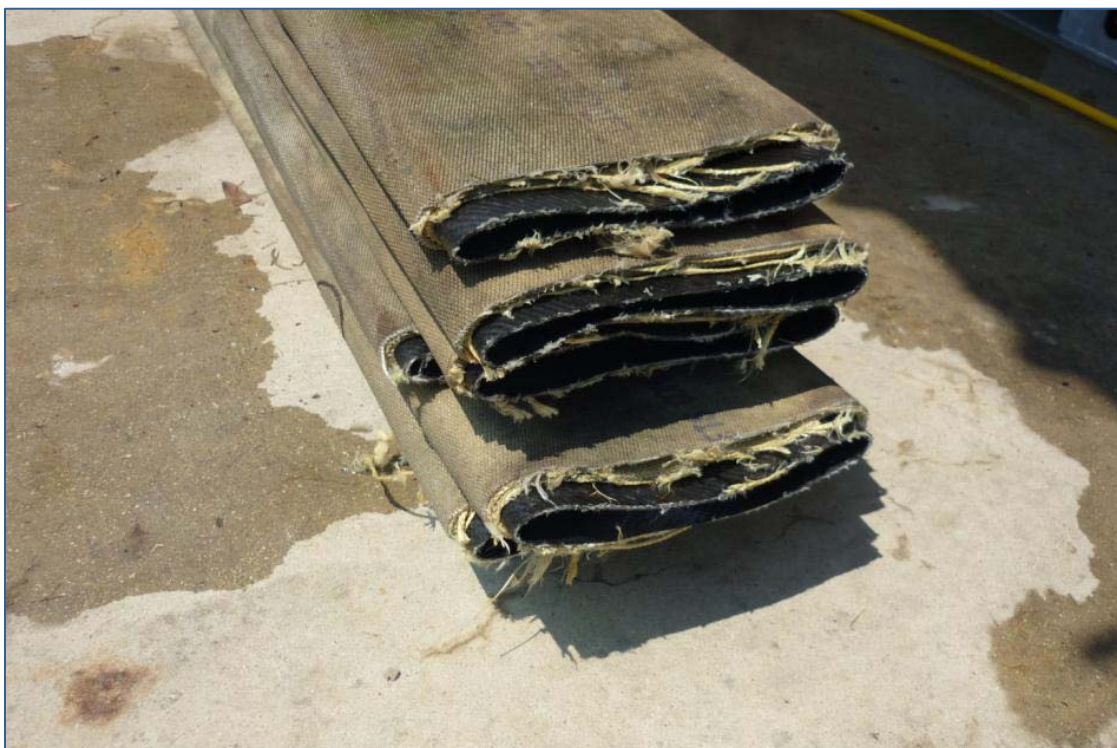
Figure 6. Liner Expansion after Cutting Specimens

The eight specimens cut from the hose reel were measured and inspected for damage. When measuring the specimens approximately 3 hours after the specimens had been cut, it was noted that the outer jacket and the inner liner were no longer even. For this reason, measurements of both the jacket and liner were recorded for each specimen. These measurements are provided below in Table 1, along with notes of any damage present. It would appear, based on the original cut length of 15 feet, that the liners expanded. Figure 5 shows the specimens just after inspection. Figure 6 shows the ends of the stacked specimens, where the difference in length of the jackets and liners is clearly visible.

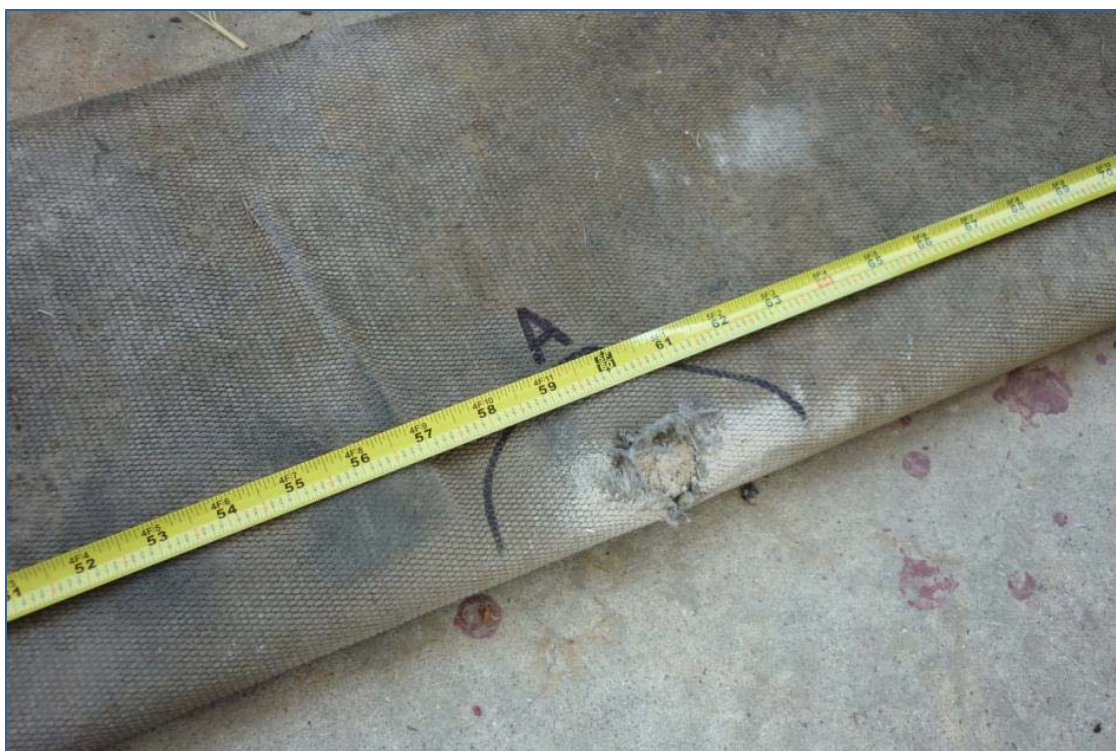
Figure 7. Hole in Outer Layer of Jacket of Specimen A

The condition of all of the cut specimens was soiled but otherwise good, with the exception of specimens A and C. There was a small hole in the outer layer of the jacket of specimen A as shown in Figure 7. This was located 60 inches from one end of specimen A. The damage to specimen C was a less significant abrasion to the outer layer of the jacket located 9 inches from one end, shown in Figure 8. Neither of the anomalies were considered to be major damage that would exclude the specimens from testing; therefore, no actions were taken to repair or remove the damage. The notes from the specimen preparation and inspection are presented in Appendix A.

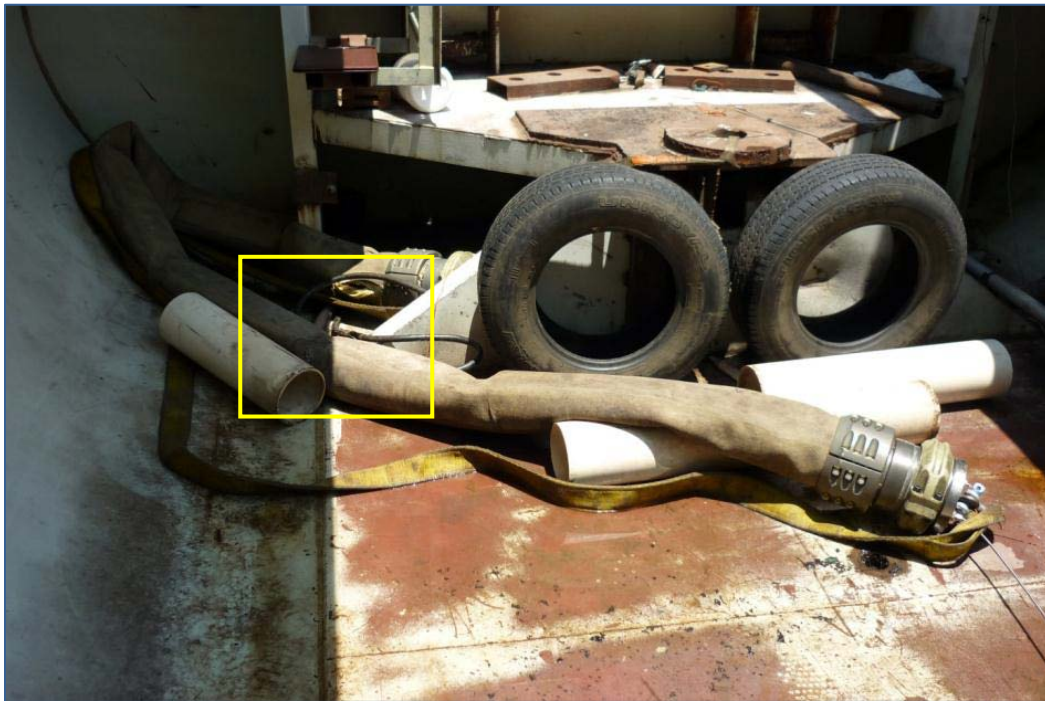
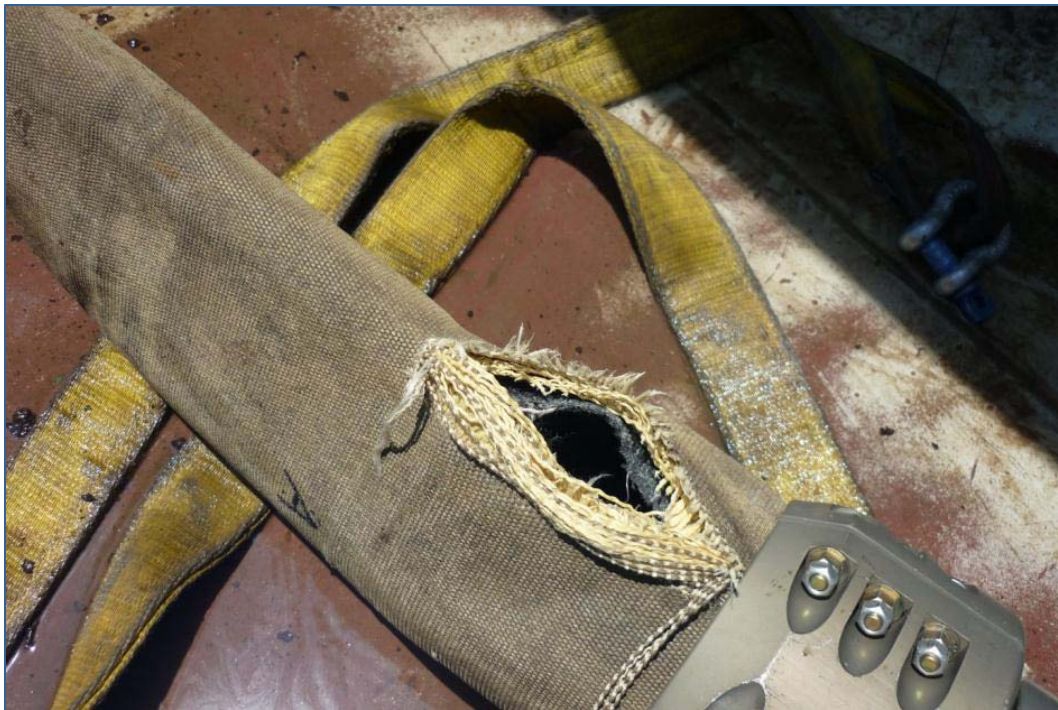
Figure 14. Specimen A Burst Testing Failure

Figure 15. Specimen A Burst Testing Failure Close-Up

Conduit Test Sample Number: <u>A</u>	Date: <u>6/9/2011</u> <u>1:40 PM</u>
Date of Manufacture: <u>07-2005</u>	
Prerequisite: Visual Inspection Notes: <u>end fittings torqued to 45 ft-lbs.</u> <u>see preparation notes</u>	
Calibration Information:	
Pressure Transducer: <u>Omega PX329-5KG5V</u>	Temperature at Test Time:
Mod# S/N: <u>060908 D330</u>	End 1: <u>94.3 °F west</u>
Cal Date: <u>6/8/2011</u>	Ambient: <u>93 °F</u>
Cal Due Date: <u>12/8/2011</u>	End 2: <u>94.1 °F east</u>
Hydrostatic Burst Test	
Conduit Length (LOA): <u>182 1/2</u> (in)	Length between Shank Ends: <u>171 7/8</u> (in)
Peak Pressure (psig): <u>1504</u> psig	Failure Mode: <u>longitudinal tear near</u>
Data Filename: <u>"BurstA"</u>	Video Record (Circle) <u>(Yes)</u> No <u>end fitting</u>
Video Tape ID # <u>"BurstA"</u>	
Test Notes/Observations: <u>tear at base of end fitting</u> <u>approximate measurements</u> <u>* camera cable was separated when conduit failed, need to secure cable to walls of tank</u> <u>failure occurred on crease along length of hose</u> <u>7" tear</u> <u>west</u> <u>east</u>

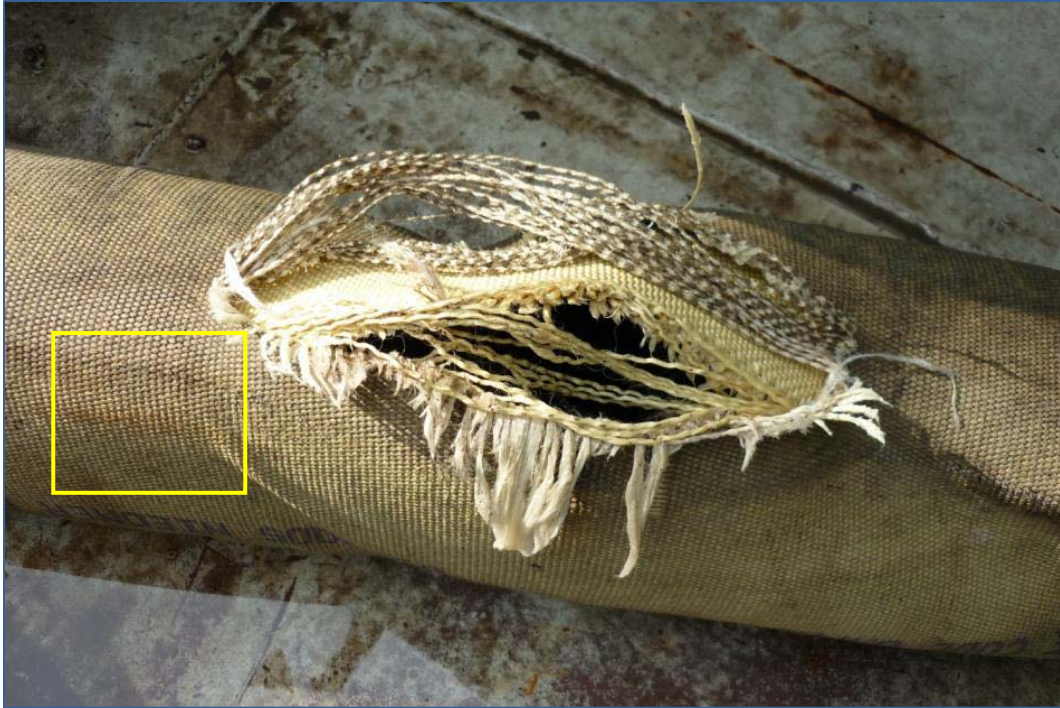
Figure 17. Specimen B Burst Testing Failure Close-Up

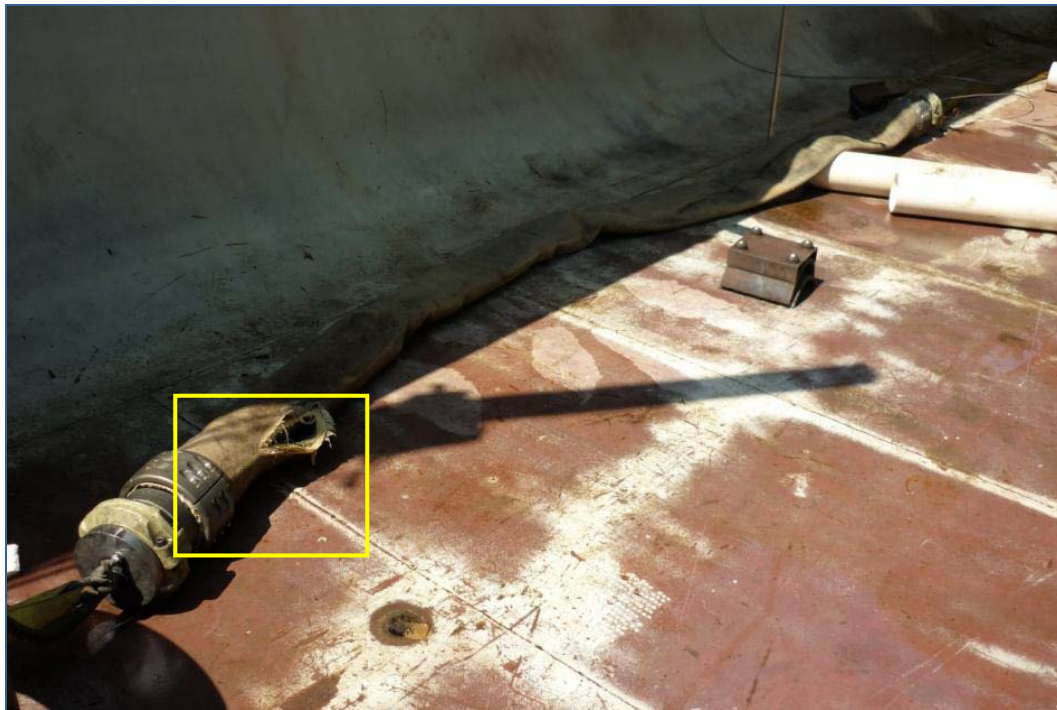
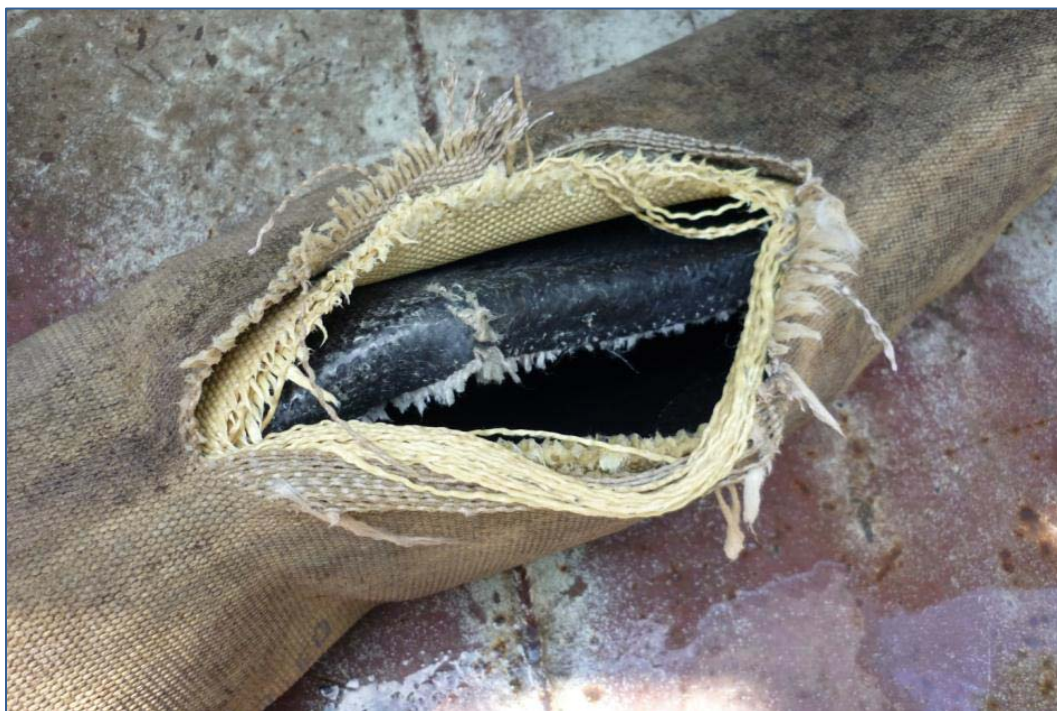
Figure 19. Specimen C Burst Testing Failure

Figure 20. Specimen C Burst Testing Failure Close-Up

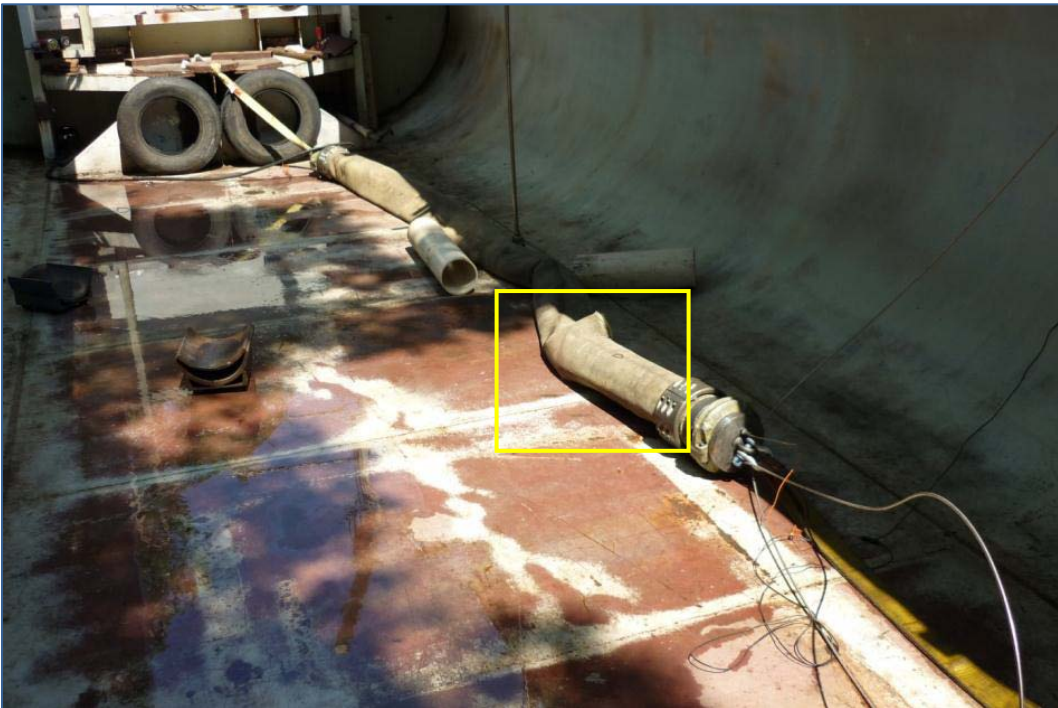
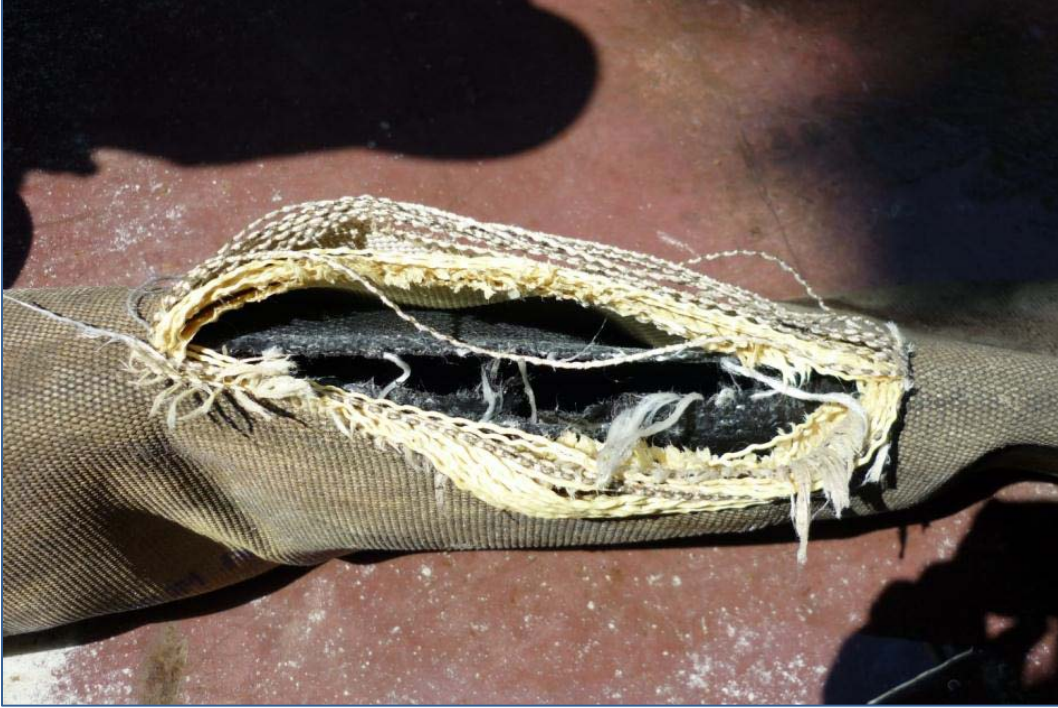
Figure 22. Specimen D Burst Testing Failure

Figure 23. Specimen D Burst Testing Failure Close-Up

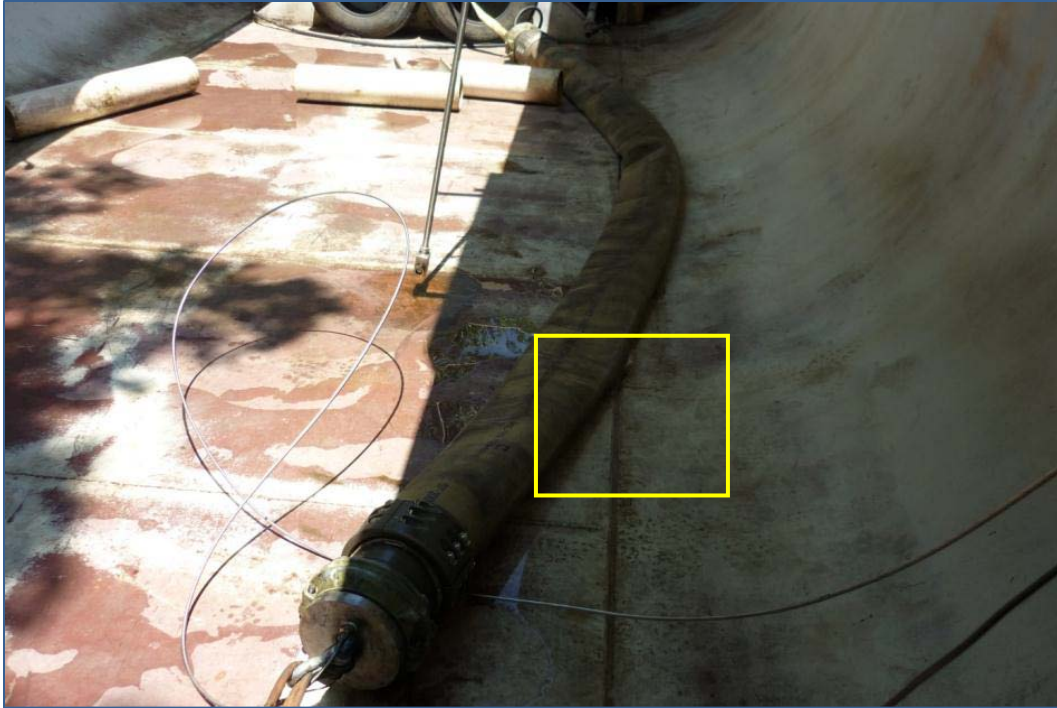
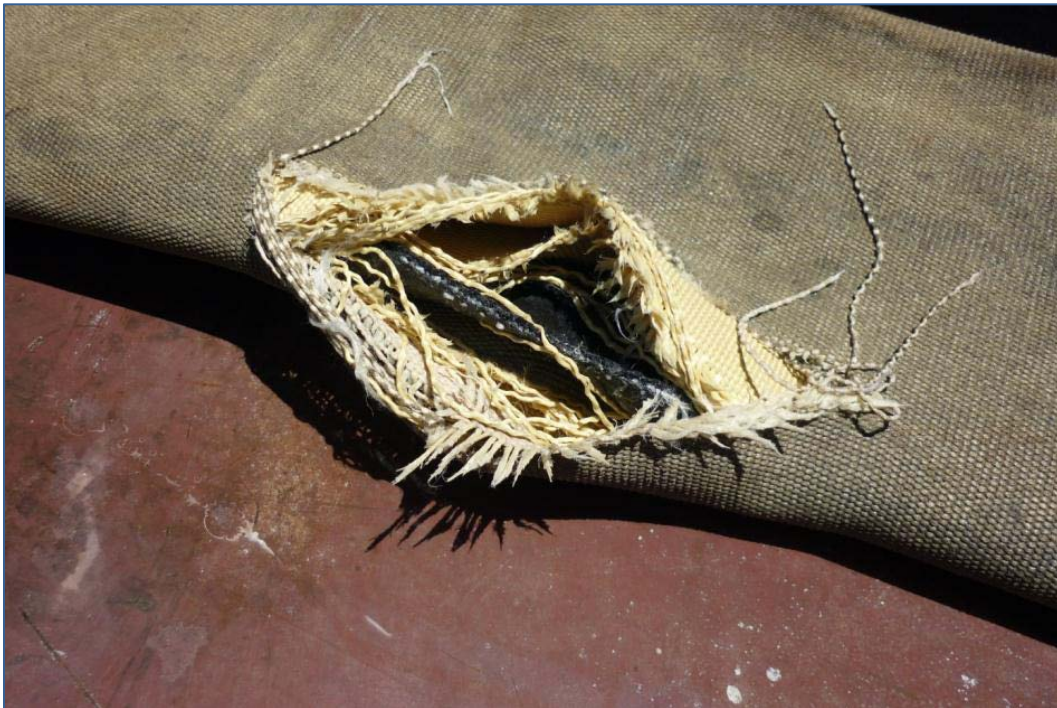
Figure 25. Specimen E Burst Testing Failure

Figure 26. Specimen E Burst Testing Failure Close-Up

Conduit Test Sample Number: E	Date: 6/13/2011 2:30 PM
Date of Manufacture: 07-2005	
Prerequisite Visual Inspection Notes: end fittings torqued to 40 ft. lbs. see preparation notes specimen stretched due to pressure cycling; stretched fibers noted on west end at edge of bending section (see photos)	
Calibration Information	
Pressure Transducer: Omega PX329-5KG5V	Temperature at Test Time:
Mod# S/N: 0608090330	End 1: 94.1°F west
Cal Date: 6/8/2011	Ambient: 99.6°F
Cal Due Date: 12/8/2011	End 2: 95.7°F east
Hydrostatic Burst Test	
Conduit Length (LOA): 186 1/16 (in)	Length between Shank Ends: 175 15/16 (in)
Peak Pressure (psig): 1324 psig	Failure Mode: longitudinal tear on crease
Data Filename: "Burst E"	Video Record (Circle): (Yes) No
Video Tape ID #: "Burst E"	
Test Notes/Observations <div style="display: flex; justify-content: space-between;"> <div> similar failures as before occurred in bending section 8" tear </div> <div> approximate measurements did not occur at stretched Fibers noted after pressure cycles </div> <div> pressurization rate: ~1300 psi/min (reduce slightly before next test) </div> </div> <div style="display: flex; align-items: center; margin-top: 10px;"> west <div style="border: 1px solid black; padding: 5px; text-align: center;"> ← 41" → </div> east </div> <p style="text-align: center; margin-top: 5px;">Conduit Section - Indicate Burst Location</p>

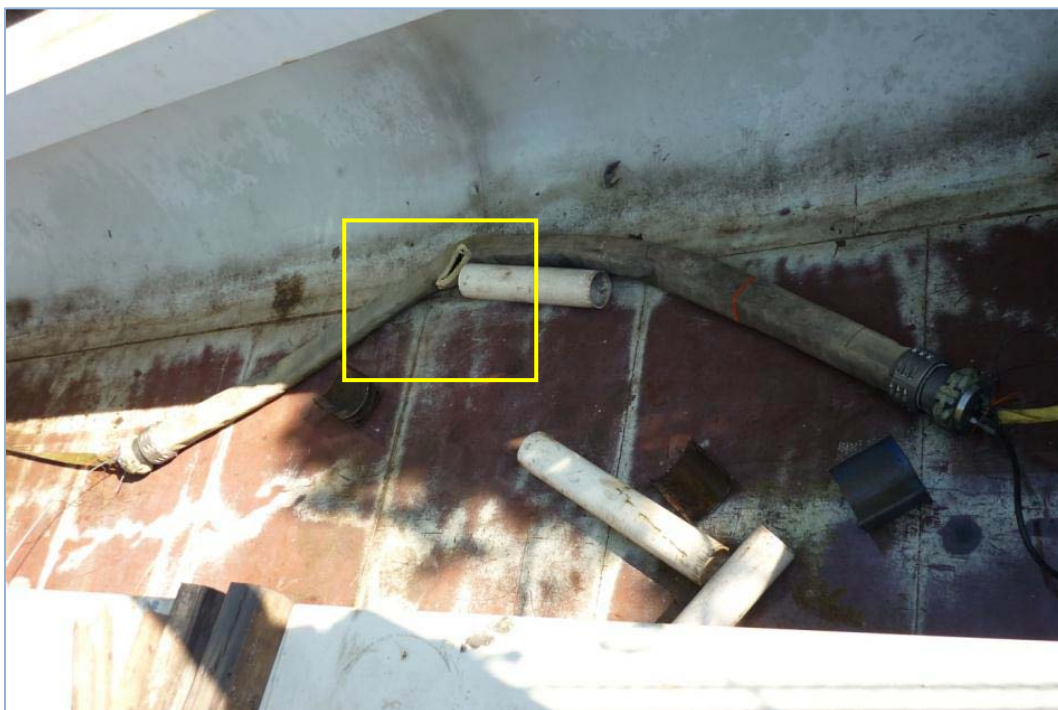
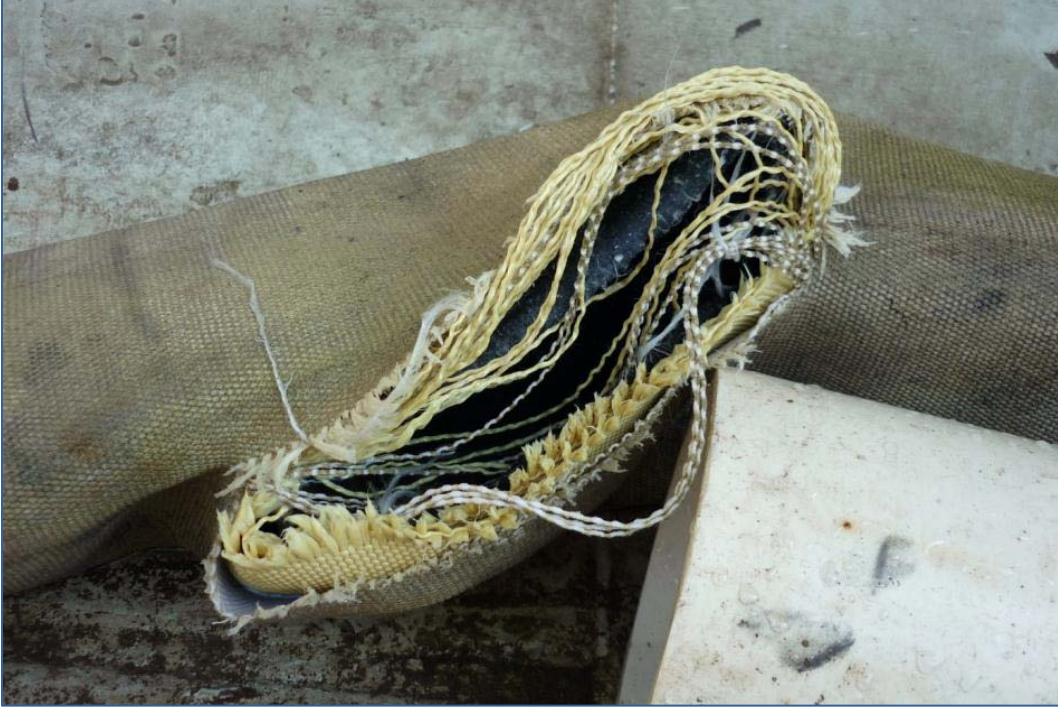
Figure 28. Specimen F Burst Testing Failure

Figure 29. Specimen F Burst Testing Failure Close-Up

Conduit Test Sample Number: F	Date: 6/14/2011 9:22 AM
Date of Manufacture: 07-2005	
Prerequisite Visual Inspection Notes: end fittings torqued to 40 ft-lbs. See preparation notes specimen stretched some due to pressure cycles; no damage to fibers was noted	
Calibration Information Pressure Transducer: Omega PX329-5KG5V Mod# S/N: 0608090330 Cal Date: 6/8/2011 Cal Due Date: 12/8/2011 Temperature at Test Time: End 1: 81.9°F west Ambient: 89.8°F End 2: 83°F east	
Hydrostatic Burst Test Conduit Length (LOA): 184 1/2 (in) Length between Shank Ends: 174 1/4 (in) Peak Pressure (psig): 1712 psig Failure Mode: longitudinal tear on crease Data Filename: "Burst F" Video Record (Circle): Yes / No Video Tape ID #: "Burst F"	
Test Notes/Observations approximate measurements pressurization rate ~ 1000 psi/min similar failure as all others; did not occur in bending section <div style="text-align: center;"> </div>

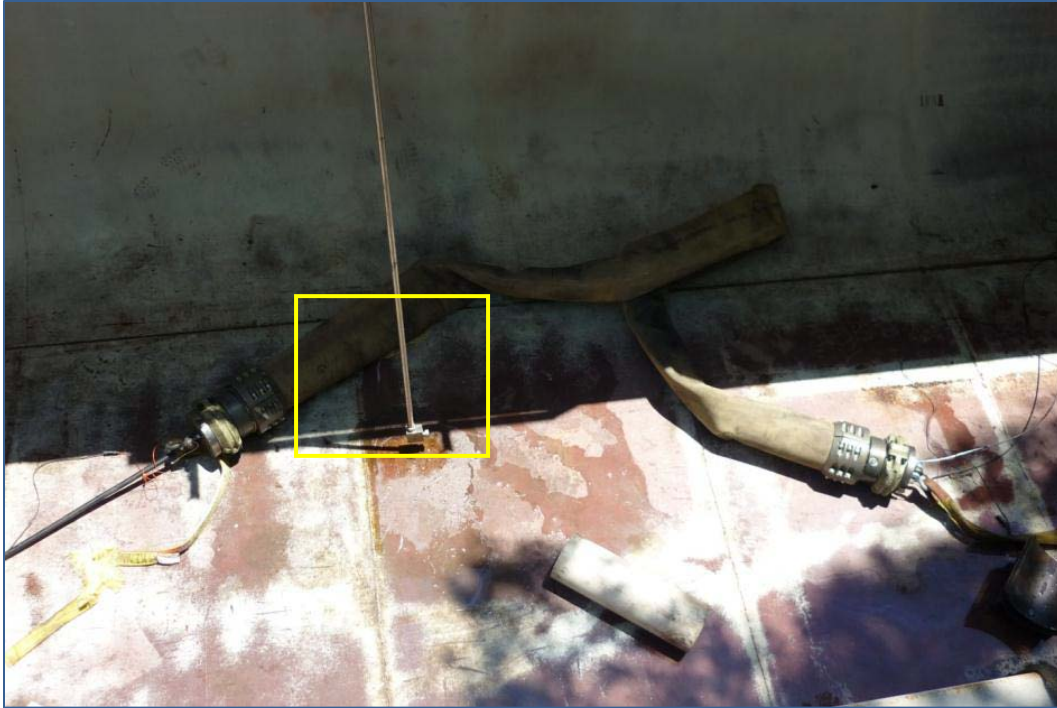
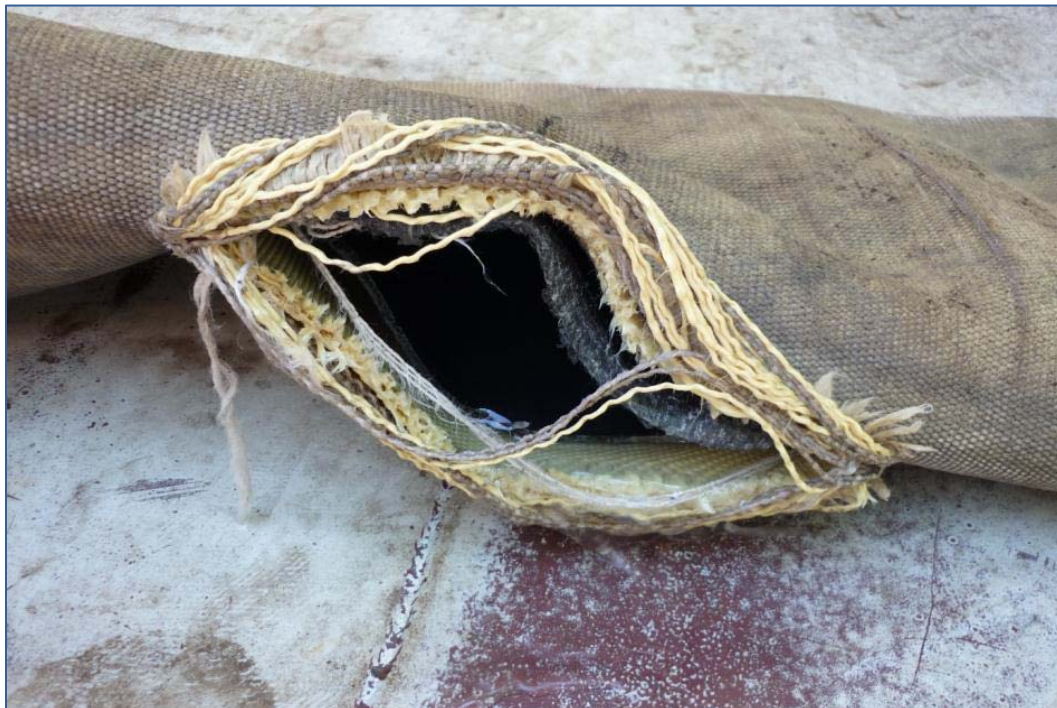
Figure 31. Specimen G Burst Testing Failure

Figure 32. Specimen G Burst Testing Failure Close-Up

Conduit Test Sample Number: <u>G</u>	Date: <u>6/14/2011</u> <u>2:08 PM</u>
Date of Manufacture: <u>07-2005</u>	
Prerequisite Visual Inspection Notes: <u>end fittings torqued to 40 ft-lbs.</u> <u>see preparation notes</u> <u>Similar stretching of specimen due to pressure cycles; no damage noted</u>	
Calibration Information Pressure Transducer: <u>Omega PX329-5KG5V</u> Temperature at Test Time: Mod# S/N: <u>060809D330</u> End 1: <u>91.8°F west</u> Cal Date: <u>6/8/2011</u> Ambient: <u>100°F</u> Cal Due Date: <u>12/8/2011</u> End 2: <u>95.2°F east</u>	
Hydrostatic Burst Test Conduit Length (LOA): <u>184 3/4</u> (in) Length between Shank Ends: <u>174 5/8</u> (in) Peak Pressure (psig): <u>1680</u> psig Failure Mode: <u>longitudinal tear in crease</u> Data Filename: <u>"Burst G"</u> Video Record (Circle) <u>Yes</u> No Video Tape ID #: <u>"Burst G"</u>	
Test Notes/Observations <u>approximate measurements</u> <u>pressurization rate ~ 1300 psi/min</u> <u>similar failure as all others</u> <u>east tether broke upon failure</u> <u>10" tear</u> <u>(valve position was not changed, though)</u> <u>occurred in bending section</u> <div style="display: flex; align-items: center;"> west <div style="border: 1px solid black; flex-grow: 1; position: relative;"> <div style="position: absolute; left: 0; top: 0; bottom: 0; width: 100%;"></div> <div style="position: absolute; right: 0; top: 0; bottom: 0; width: 100%;"></div> <div style="position: absolute; left: 10%; top: 50%; transform: translateY(-50%);">← 27" →</div> </div> east </div> <p style="text-align: center;">Conduit Section – Indicate Burst Location</p>

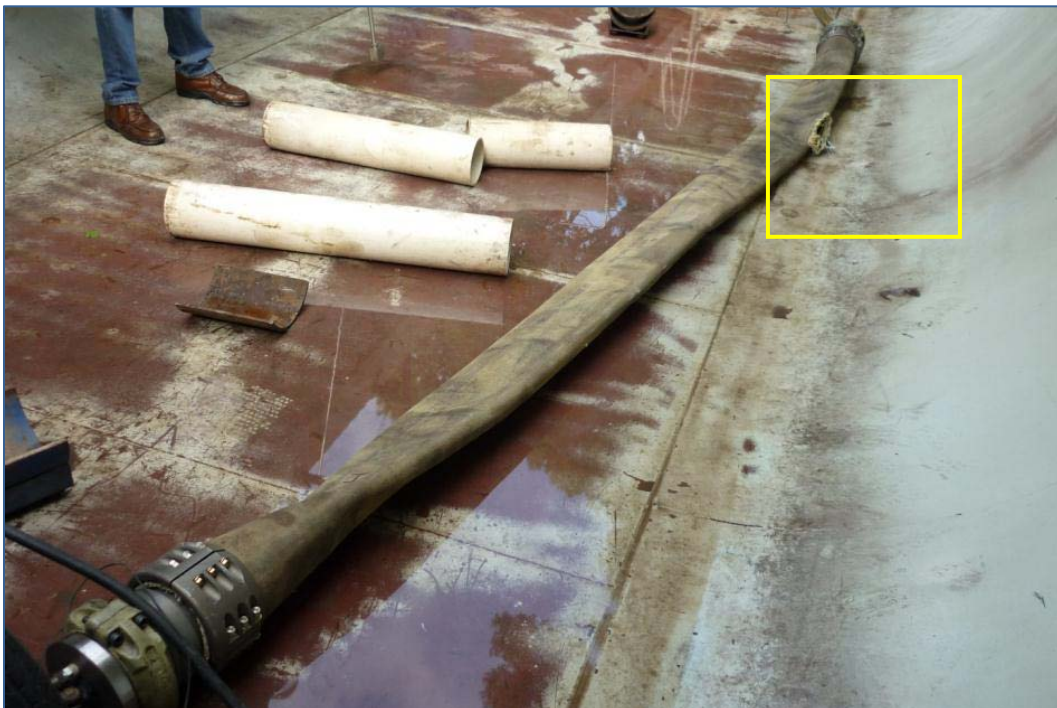
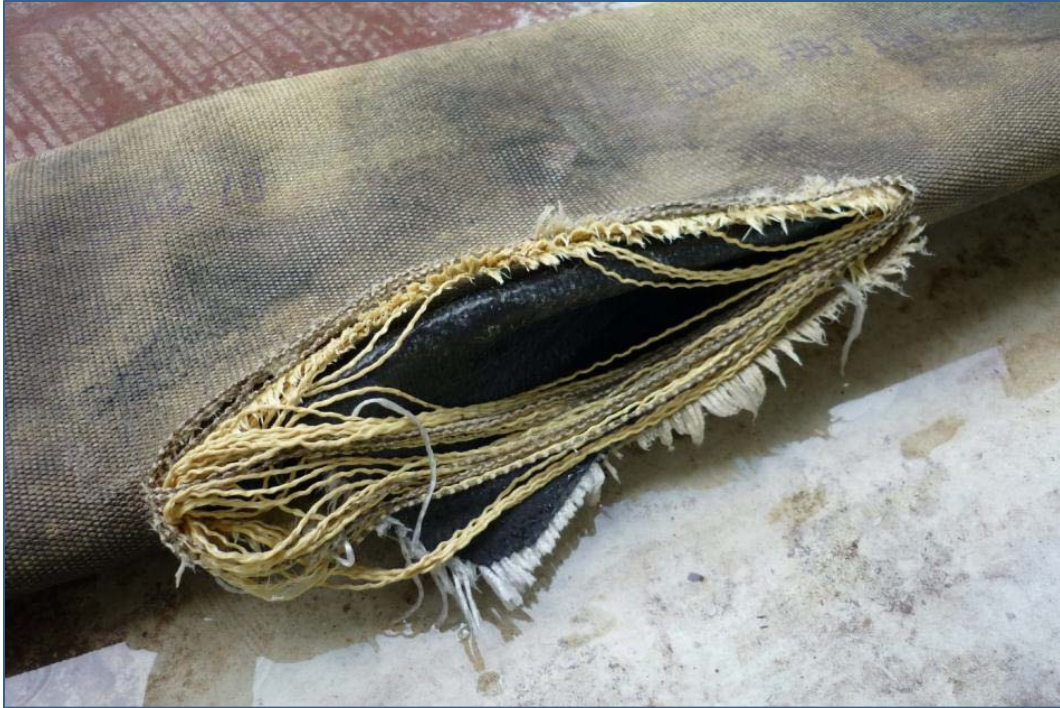
Figure 34. Specimen H Burst Testing Failure

Figure 35. Specimen H Burst Testing Failure Close-Up

Conduit Test Sample Number: <u>H</u>	Date: <u>6/15/2011 9:32 Am</u>
Date of Manufacture: <u>07-2005</u>	
Prerequisite Visual Inspection Notes: <u>end fittings torqued to 40 ft-lbs.</u> <u>see preparation notes</u> <u>same stretching of the specimen as before due to pressure cycles</u> <u>no damage noted</u>	
Calibration Information Pressure Transducer: <u>Omega PX329-5KGSV</u> Mod# S/N: <u>0608091330</u> Cal Date: <u>6/8/2011</u> Cal Due Date: <u>12/8/2011</u>	
Temperature at Test Time: End 1: <u>82.5°F west</u> Ambient: <u>84.4°F</u> End 2: <u>83.8°F east</u>	
Hydrostatic Burst Test Conduit Length (LOA): <u>187</u> (in) Length between Shank Ends: <u>176 1/2</u> (in) Peak Pressure (psig): <u>1534</u> Failure Mode: <u>longitudinal tear on crease</u> Data Filename: <u>"Burst H"</u> Video Record (Circle) <u>Yes</u> / No Video Tape ID #: <u>"Burst H"</u> <u>but bladder tear was different; it seemed to blow-out of the tear in the jacket</u>

Test Notes/Observations <u>approximate measurements</u> <u>pressurization rate ~ 1000 psi/min</u> <u>13" tear and bladder blow-out</u> <u>Failure occurred in bending section</u> <div style="text-align: center;">

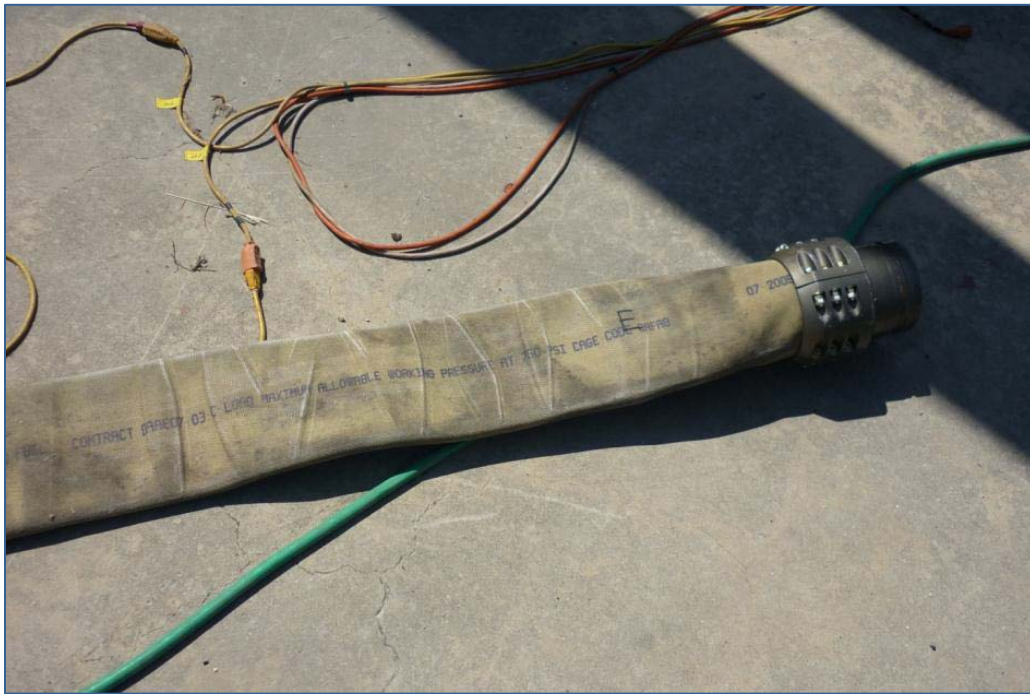
Figure 38. Creases Caused by Bending Cycles

Specimens E, F, G, and H underwent bending and pressurization cyclic testing without sustaining any considerable damage or failures; however, some effects were noted as a result of the testing. The bending cycles introduced additional creases on the specimens caused by the small (3-inch) roller, and three of these specimens failed in this region when burst. This effect is shown below in Figure 38. The pressurization cycles brought about a notable change in length for each specimen. These results are presented in Table 6. As with the previous measurements, these lengths are of the conduit (as if the end fittings were not there) pressurized to approximately 60 psig. The data sheets from the cyclic testing are provided in Appendix C.

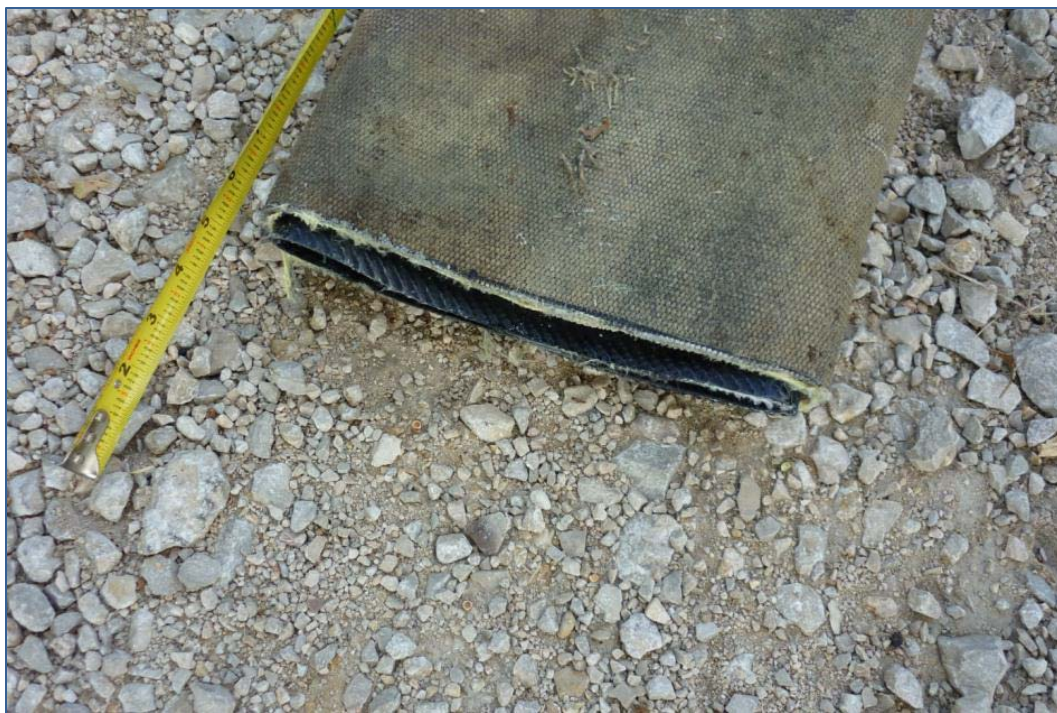
Figure 47. Specimen I, Immediately after Extraction

Additional information was requested by TARDEC regarding the apparent expansion of the conduit liner observed during extraction and inspection of the specimens. A ninth specimen, labeled I, was extracted from the same hose reel as the first eight samples. Because the liner had already expanded on the end of the hose reel, the first 15-foot length was cut off as scrap and then Specimen I, approximately 15 feet long, was cut. Immediately after extracting Specimen I, the jacket and liner lengths were measured. Note that the liner had already expanded approximately one inch. These measurements were repeated six times at the intervals noted in Table 7. Over a period of 48-hours from the time of extraction, the liner expanded a total of 3 inches, with the majority of this expansion occurring in the first six hours. Specimen I, just after cutting and then after 48 hours, is shown below in Figure 47 and Figure 48, respectively. Notes from this investigation are presented in Appendix E.

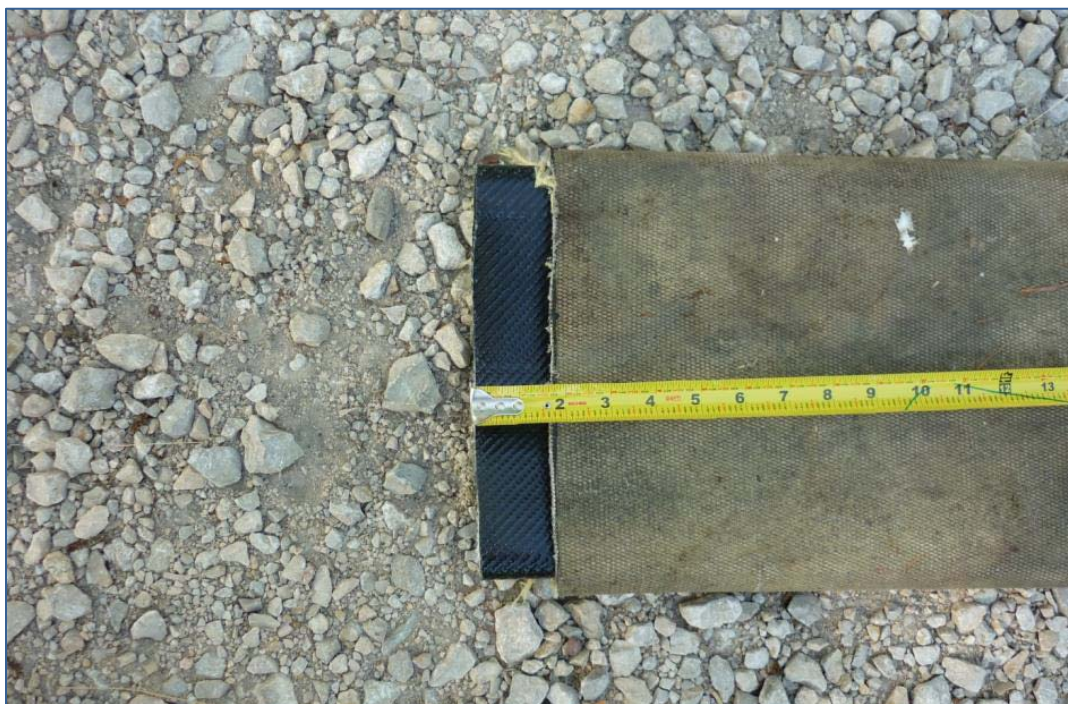
Figure 48. Specimen I, 48 Hours after Extraction

- Further documentation of the liner expansion was made. The liner was found to expand immediately after cutting, and expanded a total of three inches per a 15-foot specimen over a period of 48-hours. The majority of this expansion occurred within six hours after cutting.
- As with any experimental data, testing of more specimens would provide more extensive data and a more accurate representation of the performance of the aged Niedner RIFTS conduit. Also, the liner expansion could be investigated further to determine the relationship, if any, between the hose length and the amount of liner expansion.
